United States Coast Guard

Final Report for

Task Order #18

PCB Transformer Removal

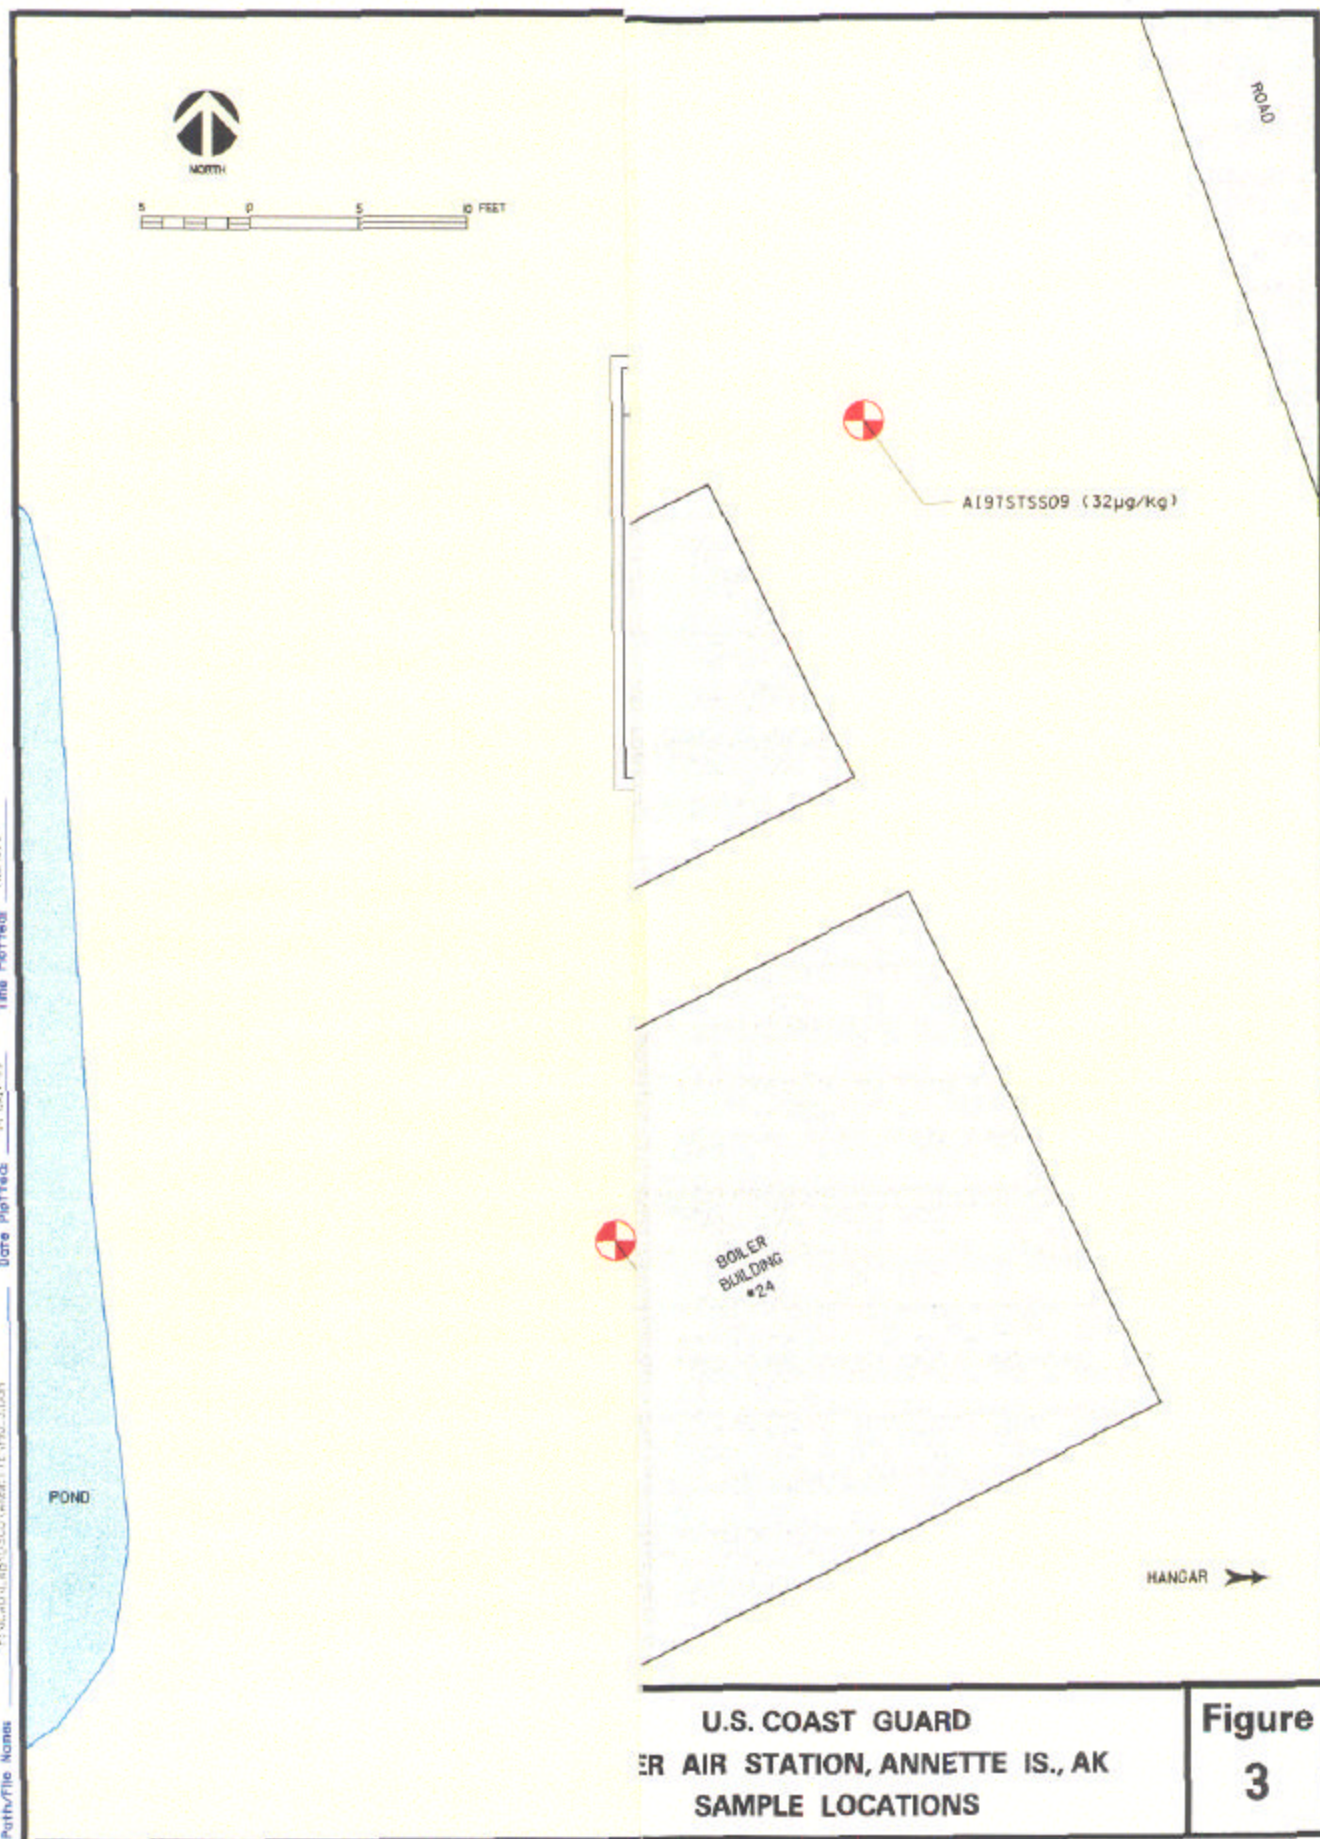
Figure
3

U.S. COAST GUARD
AIR STATION, ANNETTE IS., AK
SAMPLE LOCATIONS

Soil samples were collected from the east (AI97ESS05), south (AI97SSS06), and west (AI97WSS07 & 17/duplicate) sides of the former transformer location (Figure 3). All three of these samples were collected from native soils with high organic content at a depth of 6-8" below the surface. There was no visible evidence of contamination in these sample locations.

Sample AI97STSS09 was collected near the street in a line between the garage/Hangar site and the Transformer location (Figure 3). This sample was collected from native organic soils at a depth of 6" and appeared to be slightly oily.

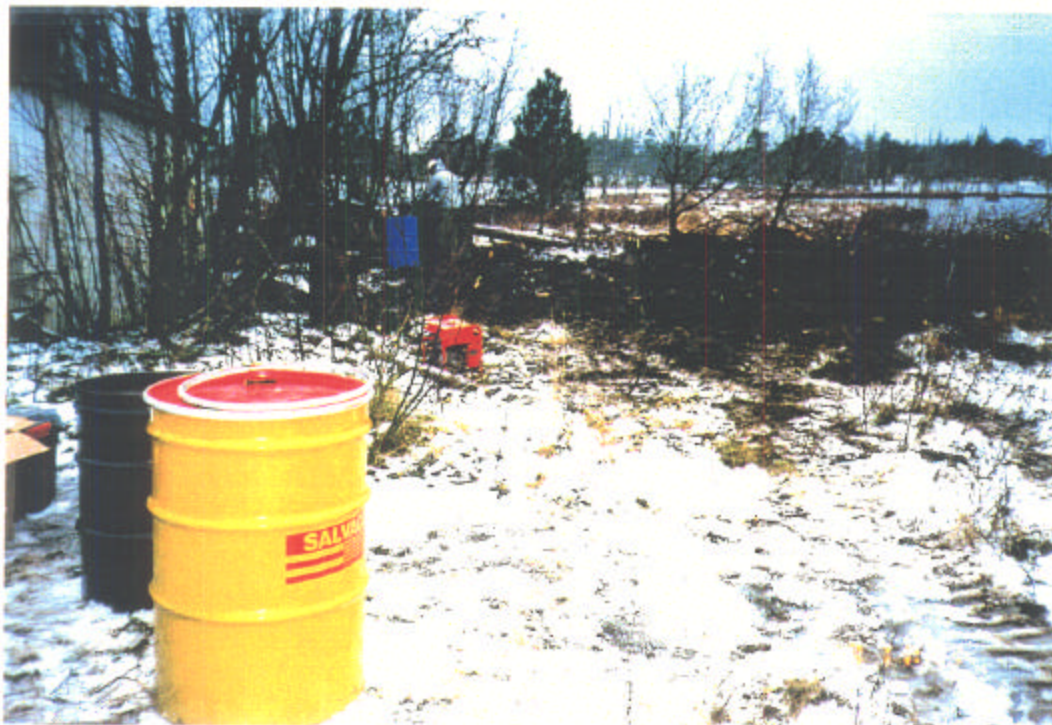
Photograph #1
Transformer Removal Site
Adjacent to Boiler Building

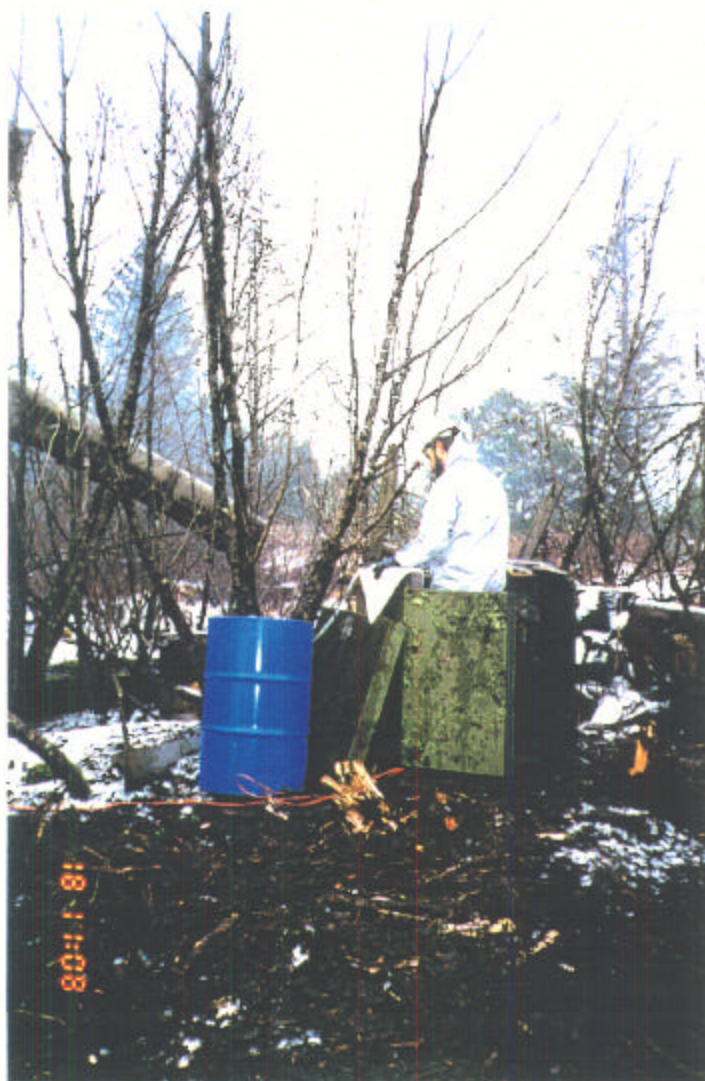
Photograph #2
Draining PCB Contaminated
Dielectric Fluid From Transformer

In order to gain access to the inside of the transformer the top lid was pried off and the sheet metal housing on the front of the transformer was removed. There were two nine inch access ports on the top of the transformer secured by ring clamps. The clamps and covers were removed to allow the transformer oil to be pumped out and the inside of the transformer to be cleaned.

A disposable electric drill-operated transfer pump, with 1/2 inch plastic tubing on either end, was used to pump the transformer oil into a DOT approved 55 gallon drum with non-removable head. Approximately 50 gallons of transformer oil were removed and placed in the drum (Photograph #2). The drum was marked with appropriate labels indicating that it contained PCBs.

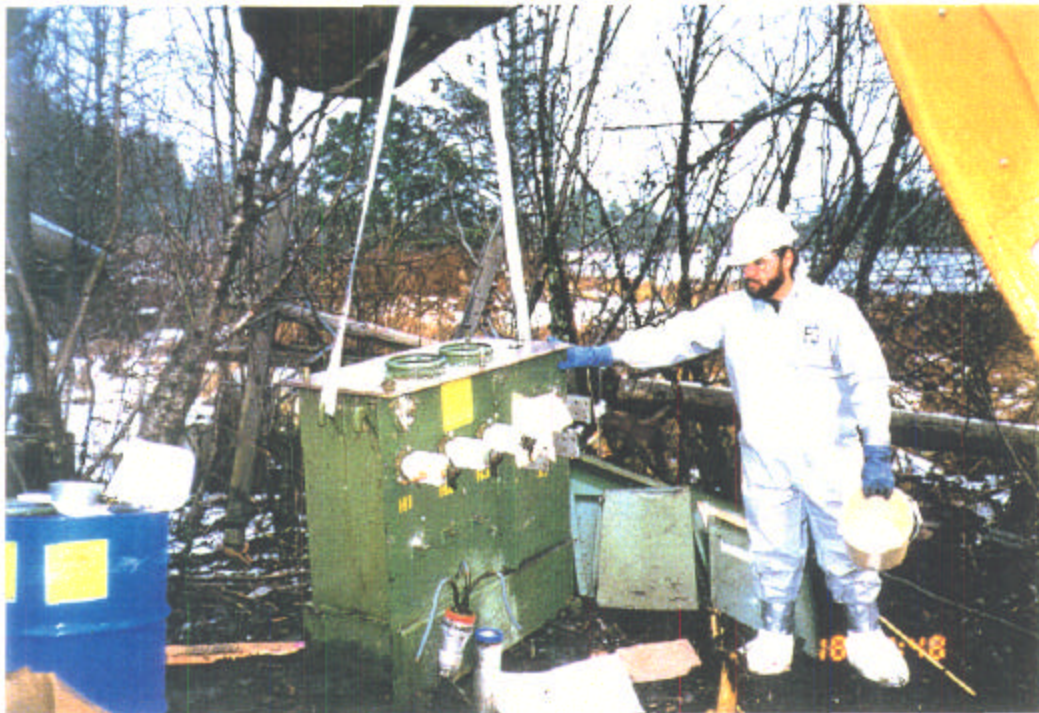
Photograph #5
Removing Drained Transformer From Concrete Pad For Disposal

Upon further inspection it was discovered that the transformer was not actually bolted to the concrete pad but was sitting in place on the anchor bolts. The transformer was lifted off the pad with a lifting sling attached to the hooks on the transformer, and temporarily placed on a piece of 6 mil polyethylene sheeting. The drained and cleaned transformer was marked as PCB Contaminated Electrical Equipment and labeled with the date removed from service (Photograph #11).

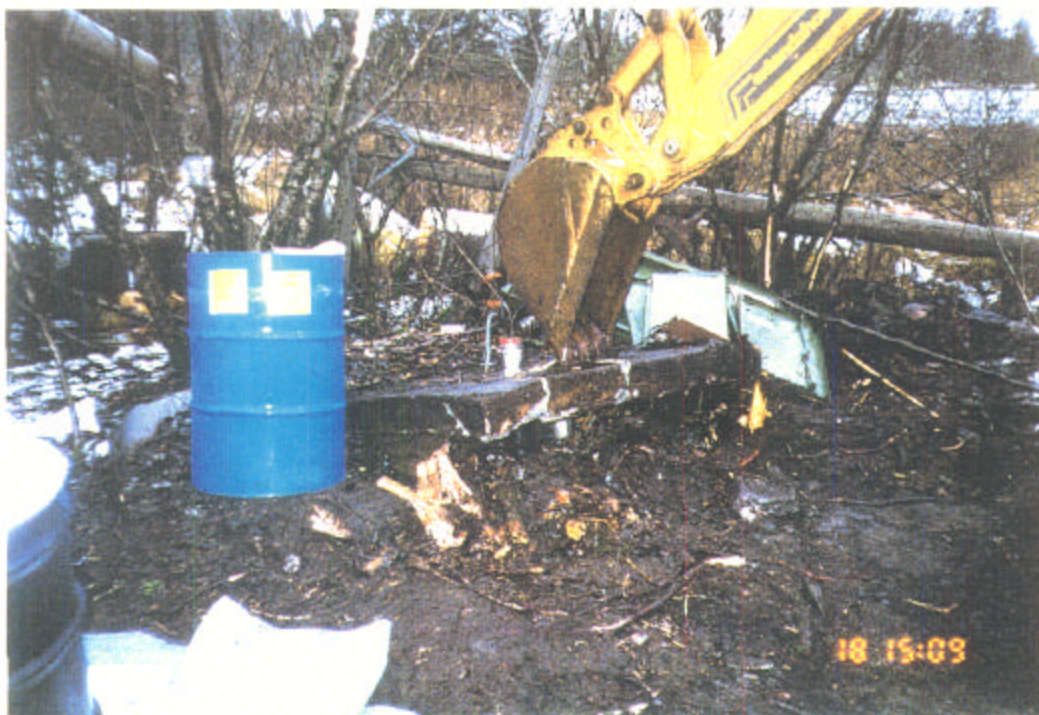
Photograph #6
Removing Concrete Pad For Disposal

The concrete pad was broken into pieces using the backhoe bucket and the pieces were placed into two 55 gallon DOT approved open top barrels and one 83 gallon DOT approved overpack drum. The drums were labeled as containing PCB contaminated debris and given the unique identifying numbers AI9703b, AI9704b, and AI9705c.

Breaking the concrete pad up was difficult due to rebar and a copper ground cable embedded in the concrete. The rebar and ground cable were cut using a Sawzall reciprocating saw and a Makita grinder with a diamond blade. In addition the ground near the transformer was very soft and made breaking up the concrete difficult. Rainy weather further hindered efforts to break up the concrete and the soils under this area were significantly disturbed. Once the concrete was broken up all concrete debris was picked up from the area and placed in the barrels for disposal.

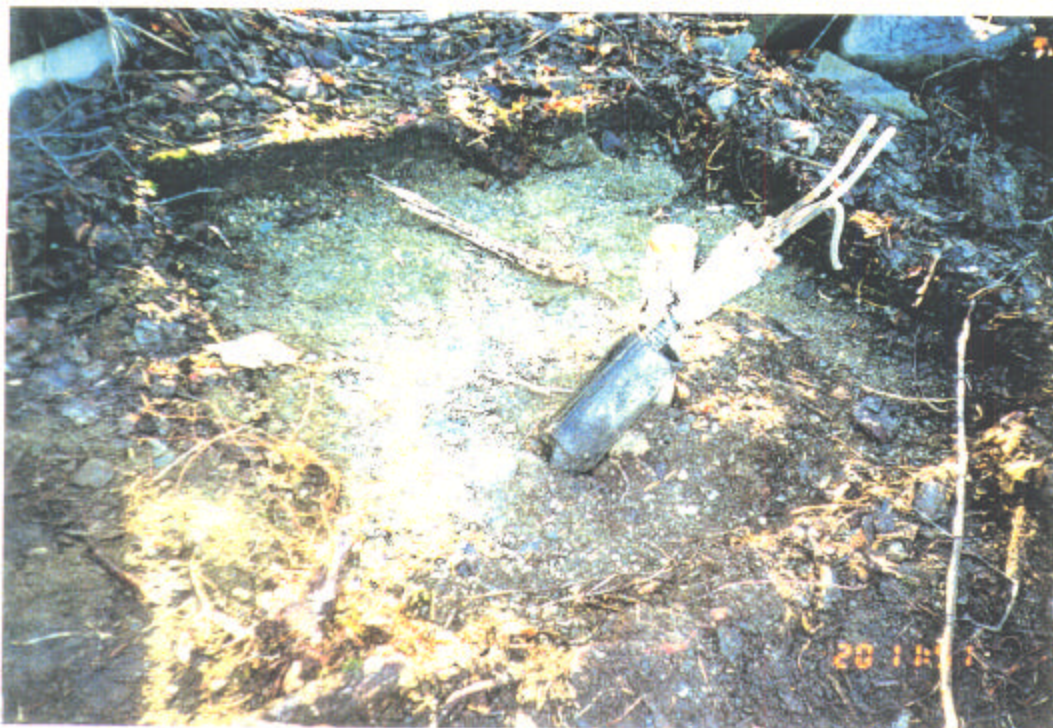
The soil under the solid part of the concrete pad appeared dry and there was no evidence of soil staining in this area. Samples AI97ESS01 and AI97WSS02 were collected under the solid part of the pad in dry and unstained soils. A split sample was collected from AI97WSS02 by the Ridolfi Engineer representative. The soil under the open part of the concrete pad was significantly darker (Photograph #7) and there was some evidence of soil staining. Sample AI97NWSS08 was collected from surface soils approximately 6" northwest of the conduit.

Photograph #7
Footprint Of Concrete Pad Following Removal (Note Soil Staining)

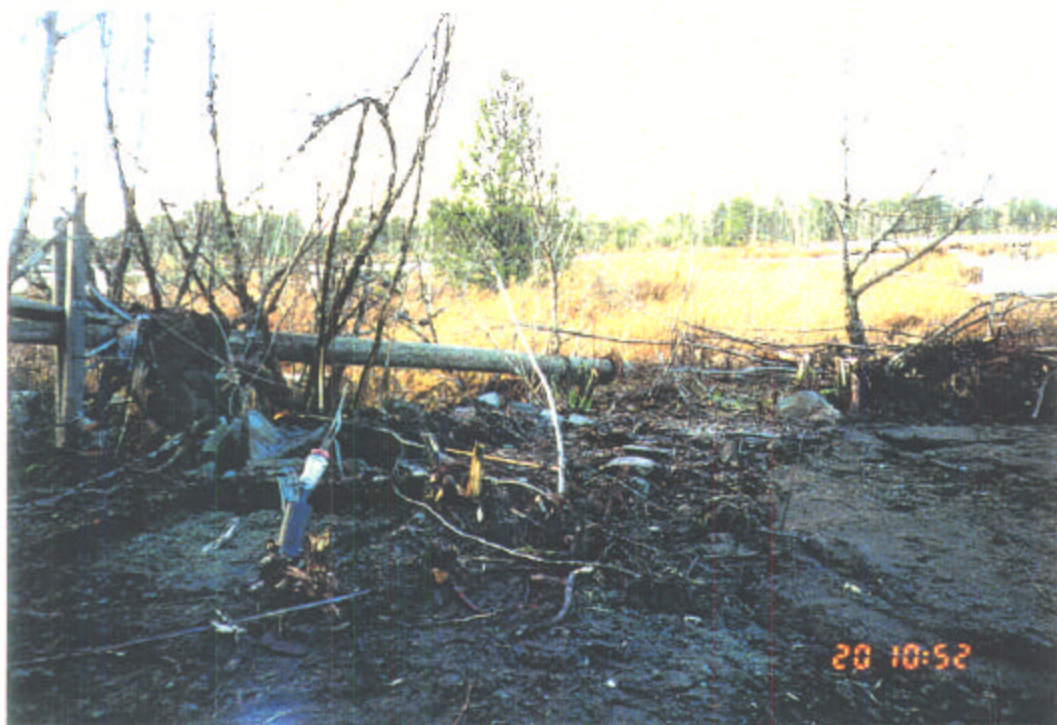
Photograph #8
Site Following Transformer and Debris Removal

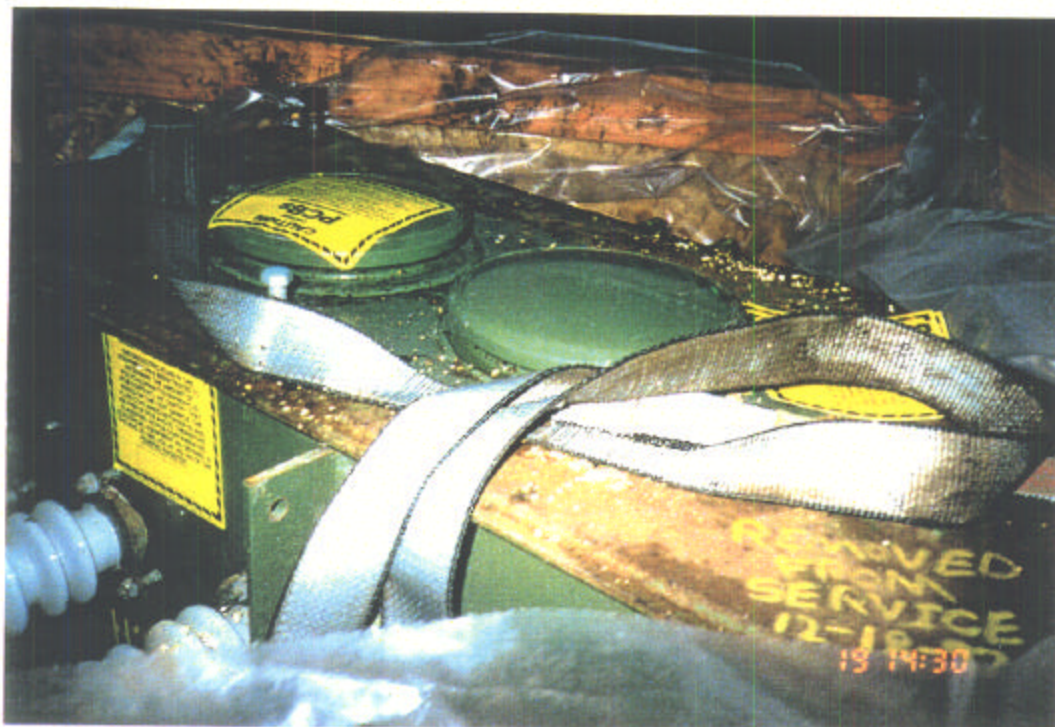
Photograph #11
Drained And Cleaned Transformer In Lined Disposal Crate
Packed With Vermiculite

The transformer was placed into the packing crate with the backhoe and the sheet metal housing was cut up and packed in the crate. The crate was then filled with vermiculite and the top was screwed on. A forklift from the Metlakatla Sawmill was used to lift the sealed crate onto the flat. The crate was then marked as containing PCB contaminated Electrical Equipment, labeled with the date removed from service (12-18-97), and a unique identifying number (AI9706d).

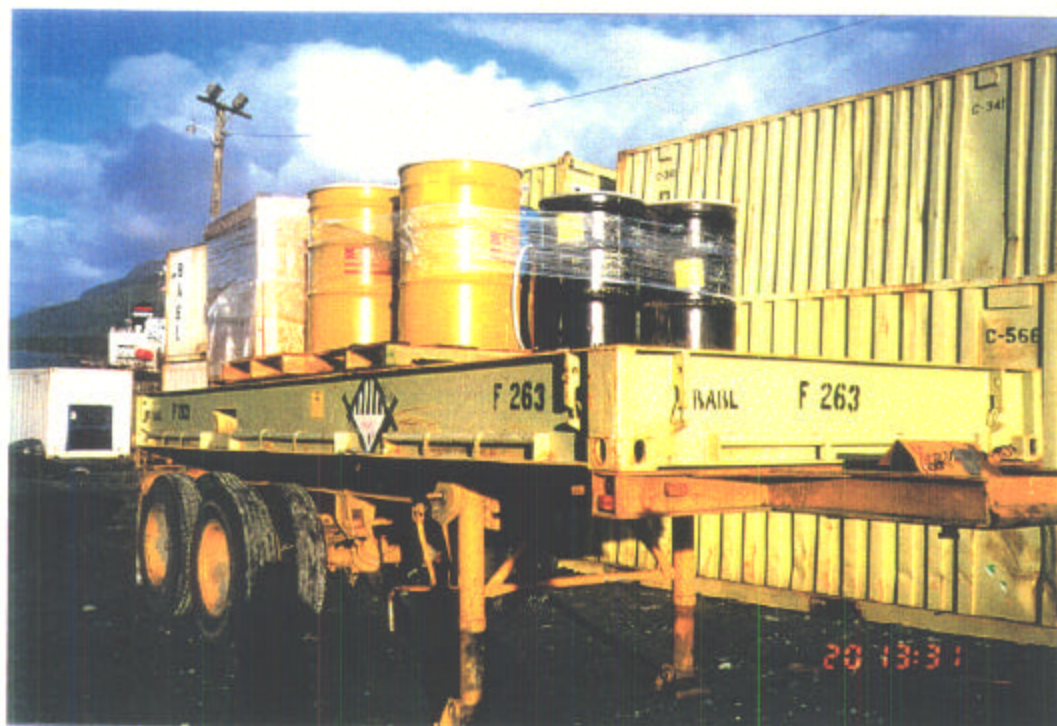
Photograph #12
Marked and Placarded Flat With Transformer And Other PCB Contaminated
Waste Awaiting Transport To ISC Ketchikan
